TIMELY OPE TIPS FOR THE MONTH - 1982

TIMELY TIPS FOR THE MONTH

ISSUE # 95

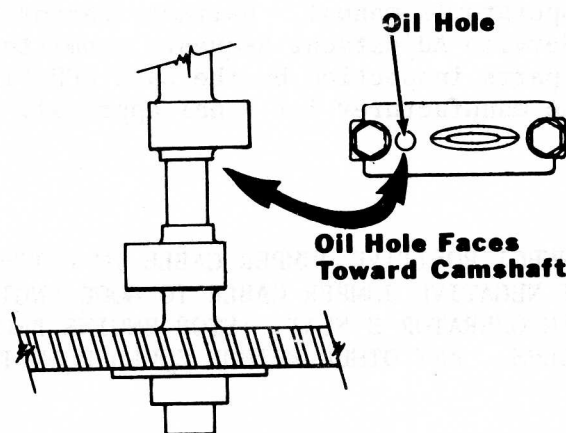
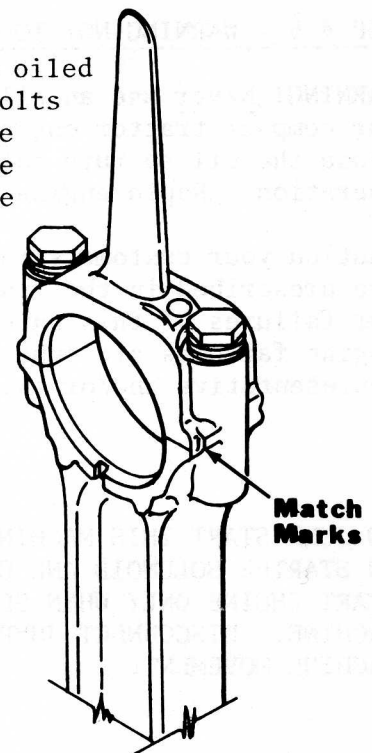
Viewed From Below

After installing rod on the clean journal, torque the oiled bolts to 25% over the recommended level, loosen the bolts and re-torque to correct level. Before installing the rod check that the match marks correspond and that the oil hole faces towards the camshaft. This will ensure correct lubrication of the connecting rod bearing.

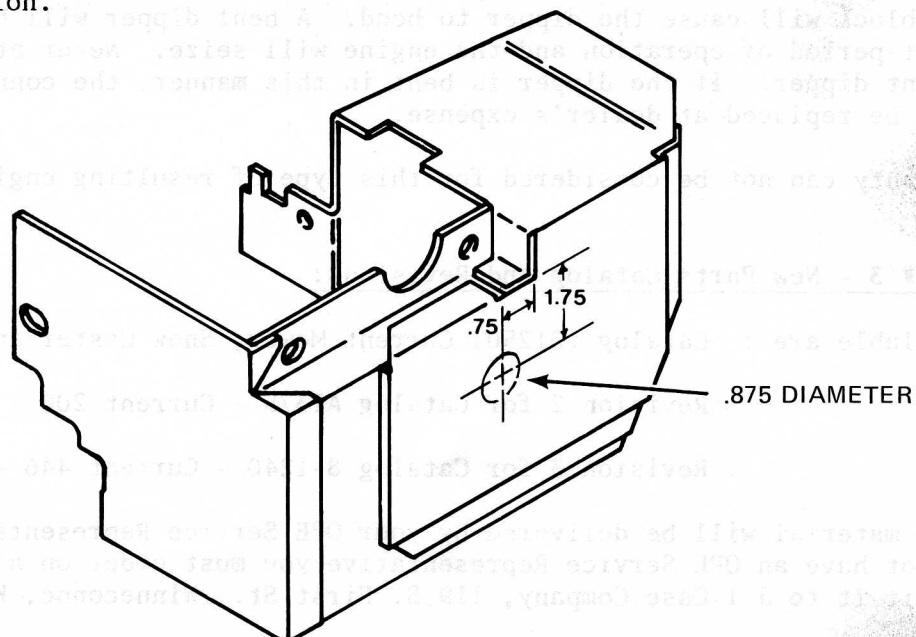
To install the 1/4-20 x 1/2" NC bolt and 1/4" lockwasher it is necessary to cut a 7/8" diameter hole in the exhaust air duct as follows:

1. Remove the engine enclosure and battery.
2. Center punch a pilot mark in the air duct according to the following illustration.

3. Using a 3/8" drill with a 7/8" diameter hole saw cut a 7/8" hole in the air duct as illustrated.
4. Using a 1/4" drive socket and extension install a 1/4-20 x 1/2" long bolt, P/N 113-1, and 1/4" lockwasher, P/N 192-19, to anchor the muffler tab to the cylinder head. Position the lockwasher split so it seats against the tab rather than the slotted hole. Torque the bolt to between 50 and 60 inch pounds (5.6 - 6.7 Nm).

5. IMPORTANT - Install a 7/8" button plug, Case P/N 205-36 in the sawed hole to prevent excessive heat leakage and subsequent engine overheating and vaporlocking.

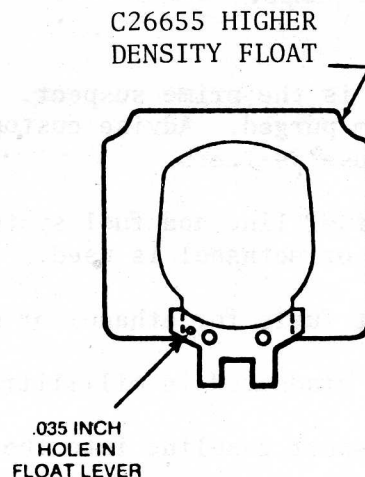
The higher density float, P/N C26655, has also been available in Service Parts Supply since mid September. The new P/N C26655 float can be identified by an extra .035" hole in the float lever as illustrated.

Although the higher density float will better resist swelling in ethanol or methanol contaminated fuels, their use is not recommended. Any float damage resulting from their use will not be covered under warranty.

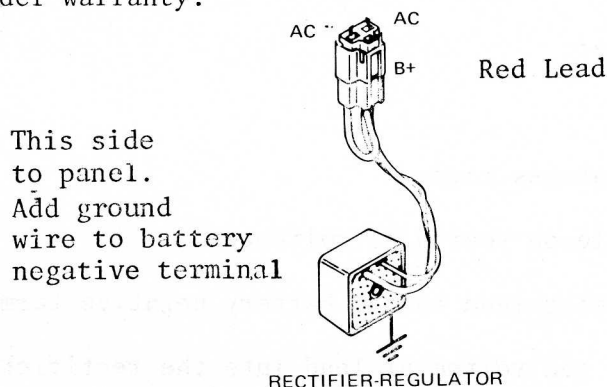
13. Start and run the engine at full throttle.
14. Place one voltmeter probe into the rectifier regulator plug where the yellow wire from the rectifier regulator is connected. Place the other voltmeter probe into the rectifier regulator plug where the "looped" yellow wire is connected.
15. If a minimum of 28 volts AC registers on the AC voltmeter, the rectifier regulator is faulty and must be replaced.
16. If AC output is "0", check connections back to stator. Remove flywheel, check for "dead" magnet ring or open stator windings.

This test procedure is in Electrical System, Section 9-51171, in your OPE Service Manual.

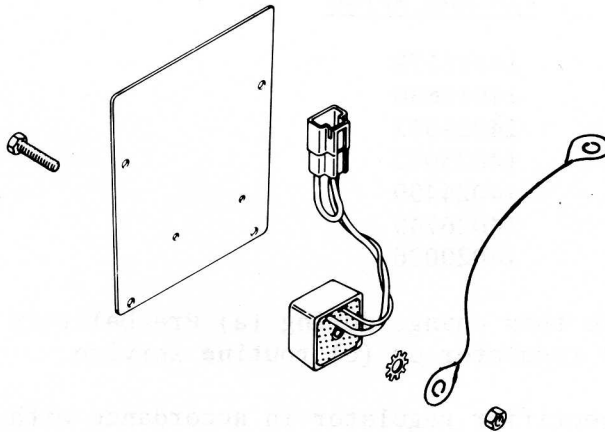
The rectifier regulator can fail prematurely if it has a poor electrical ground or poor heat transfer connection. Beginning with the PIN's below:

5. Assemble in the following sequence:

- a) Put the bolt through the access panel from the outside in.
 - b) Place the rectifier regulator on the bolt with its metal side tight against the inside of the access panel.
 - c) Place the star washer on the bolt.
 - d) Place one end of the ground wire on the bolt.
 - e) Install and tighten the nut.
6. Position the new ground wire around the front left corner of the hydraulic reservoir and connect to the battery negative terminal.
7. Reinstall the rear access cover.

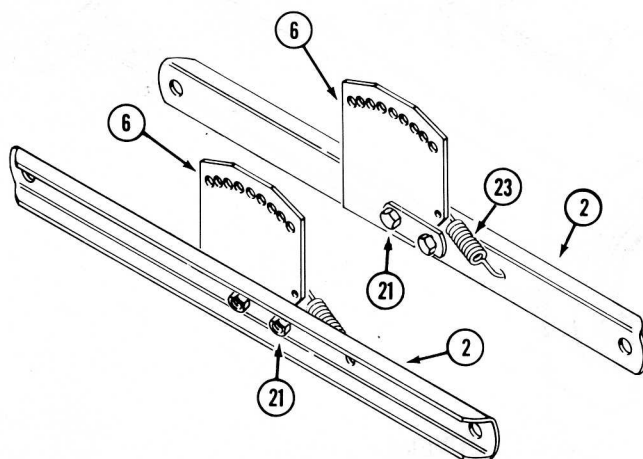
J34 and K34 Wood Splitters prior to Serial Number JK12182 may contain 2 right hand lower mounting frame assemblies (instead of 1 right and 1 left).

The lower mounting rails must be installed with the open side of the channel facing outward and the spring end of the height adjust plate facing the tractor. To correct a misassembled rail: Remove the bolt in hole (21), unhook the spring (23), reposition the height adjust plate (6) correctly, hook the spring and secure the height adjust plate with the bolt.
